AERONAUTICAL RESEARCH LABORATORY

Aircraft Materials Report 123

**ION VAPOUR DEPOSITED (IVD) ALUMINIUM COATINGS FOR THE
CORROSION PROTECTION OF HIGH STRENGTH STEEL**

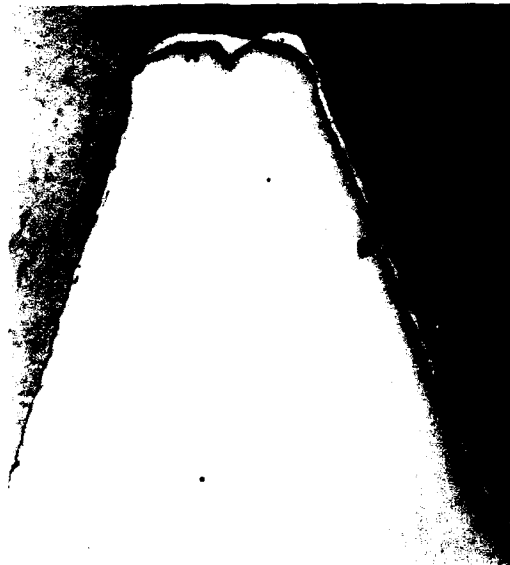
Figure 13: Metallographic section through a single thread of an aircraft bolt showing the variation in IVD coating thickness between the thread crest (A), surface (B) and root (C). MAG: X128

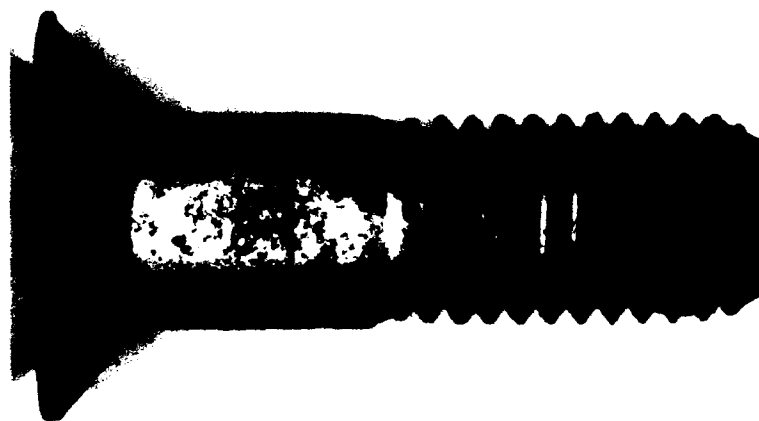
Figure 26: Advanced corrosion of the IVD-Al coating. MAG: X7
